HUNTERS LAKE DAM

NDS ID NO. PA-356

PHASE I INSPECTION REPORT
NATIONAL DAM INSPECTION PROGRAM

NAME OF DAM: Hunters Lake Dam
STATE LOCATED: Pennsylvania
COUNTY LOCATED: Sullivan
STREAM: Trout Run
DATE OF INSPECTION: May 24, 1979

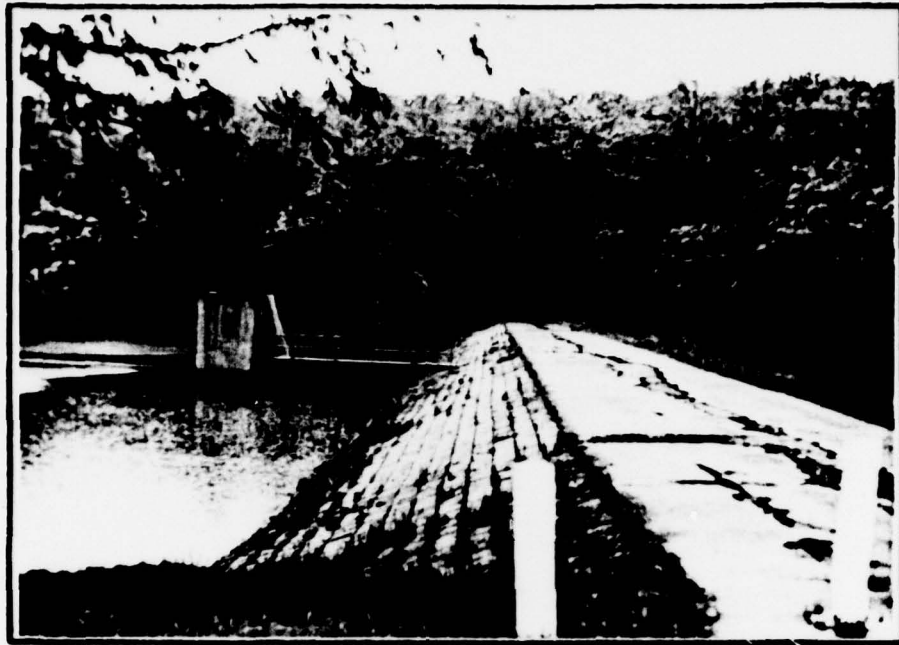
Overview of upstream slope and crest.

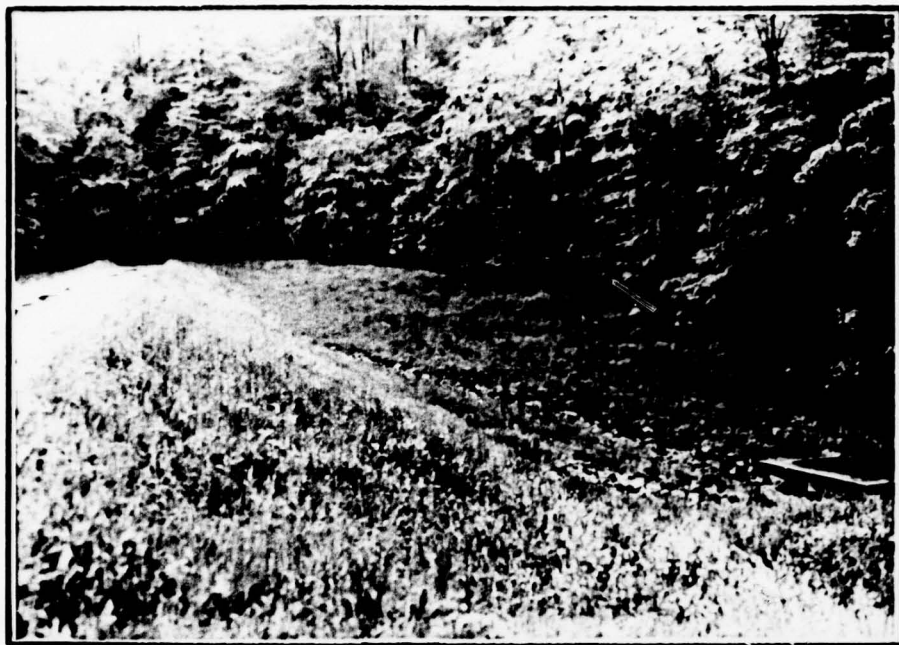
Downstream slope and left abutment.

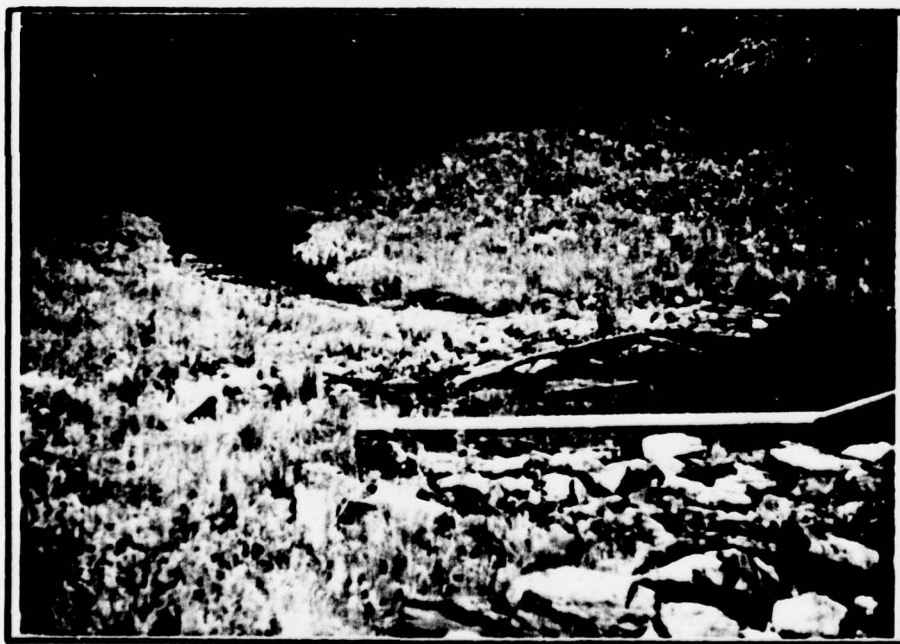
VISUAL EXAMINATION OF	OBSERVATIONS	REMARKS OR RECOMMENDATIONS
VEGETATION	Grass on downstream slope.	
JUNCTION OF EMBANKMENT AND ABUTMENT, SPILLWAY AND DAM	Both abutments appear to be good.	
ANY NOTICEABLE SEEPAGE	Seepage from rock toe. Quantity of seepage undetermined.	
STAFF GAUGE AND RECORDER	None.	
DRAINS	Underdrain in rock toe. Water was flowing out of one of these under drains to left of the impact basin.

Immediate downstream exposure.
Note perforated metal underdrain pipe.

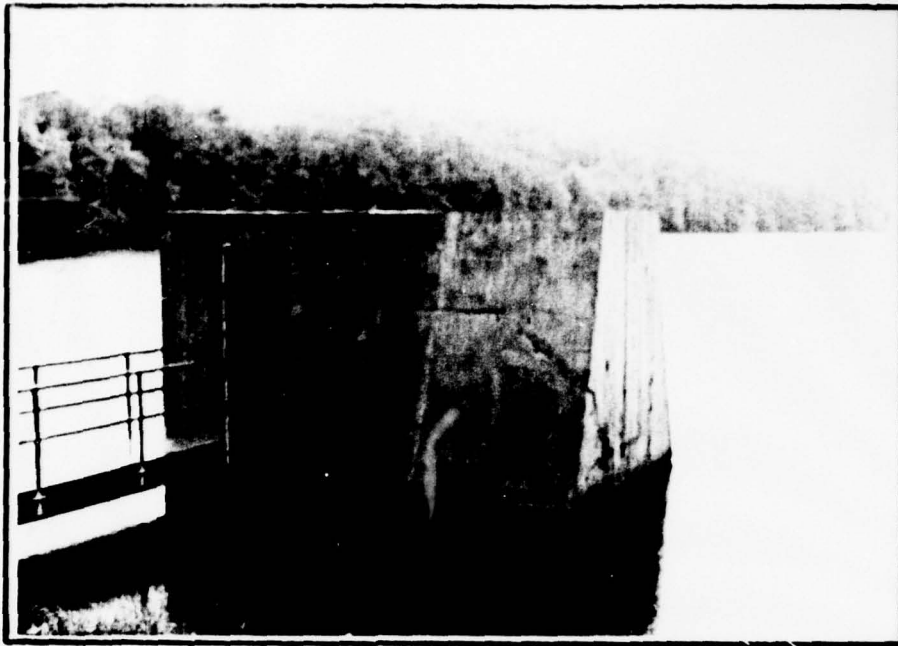
Principal spillway intake.

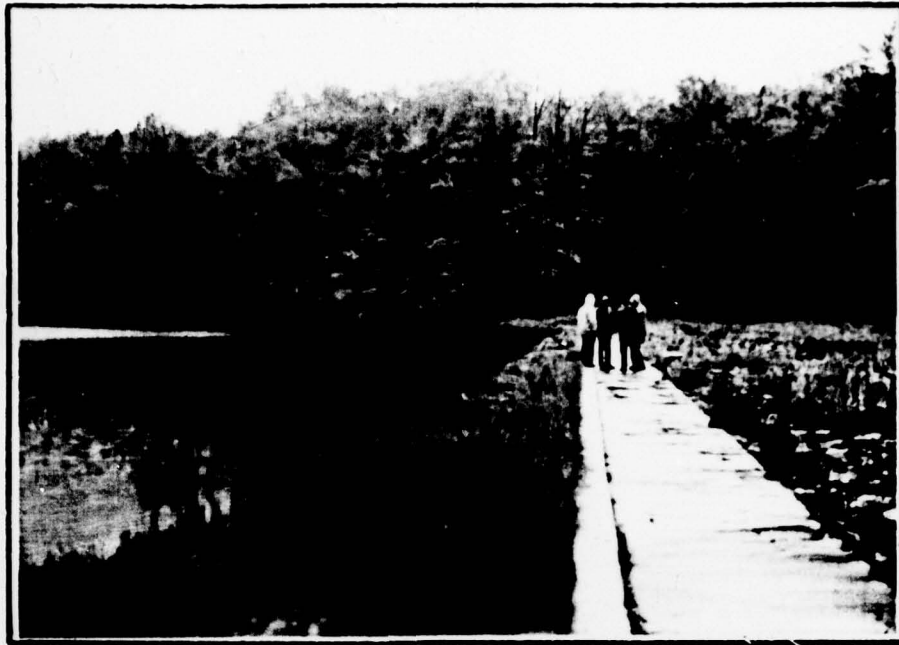
VISUAL EXAMINATION OF	OBSERVATIONS	REMARKS OR RECOMMENDATIONS
CONCRETE WEIR	Good condition.	
APPROACH CHANNEL	Lake.	
DISCHARGE CHANNEL	Discharge channel is a natural drainage way formed by a saddle.	
BRIDGE AND PIERS	None.

Spillway weir.

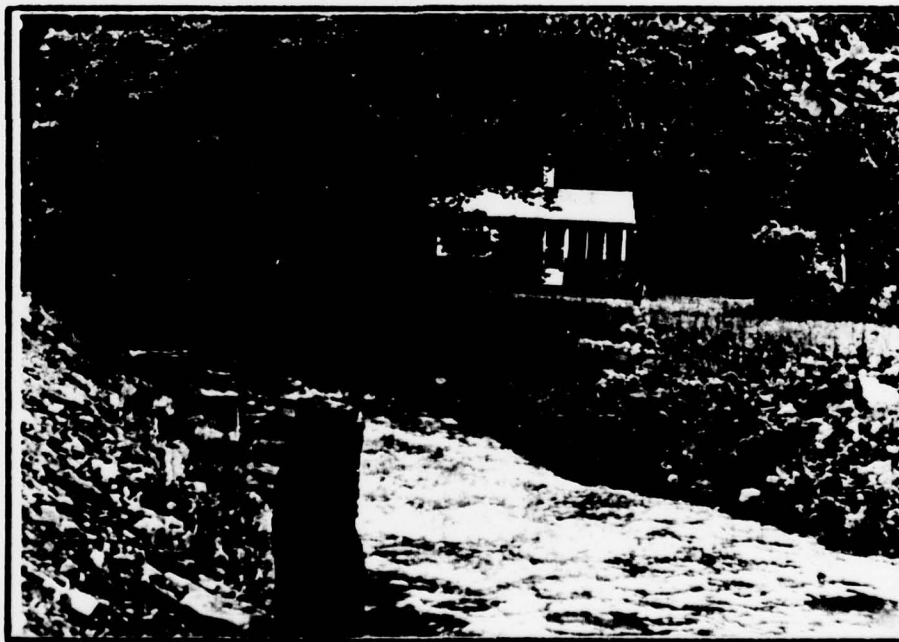
VISUAL EXAMINATION OF	OBSERVATIONS	REMARKS OR RECOMMENDATIONS
CONDITION (OBSTRUCTIONS, DEBRIS, ETC.)	Narrow and steep downstream channel.	
SLOPES	Slopes appeared to be stable.	
APPROXIMATE NO. OF HOMES AND POPULATION	Approximately 14 homes with 56 people.

Residence downstream of dam.
